Natural hazards risk management in highways

An experience from Portugal

Paulo Barreto

A24 Motorway (Portugal)

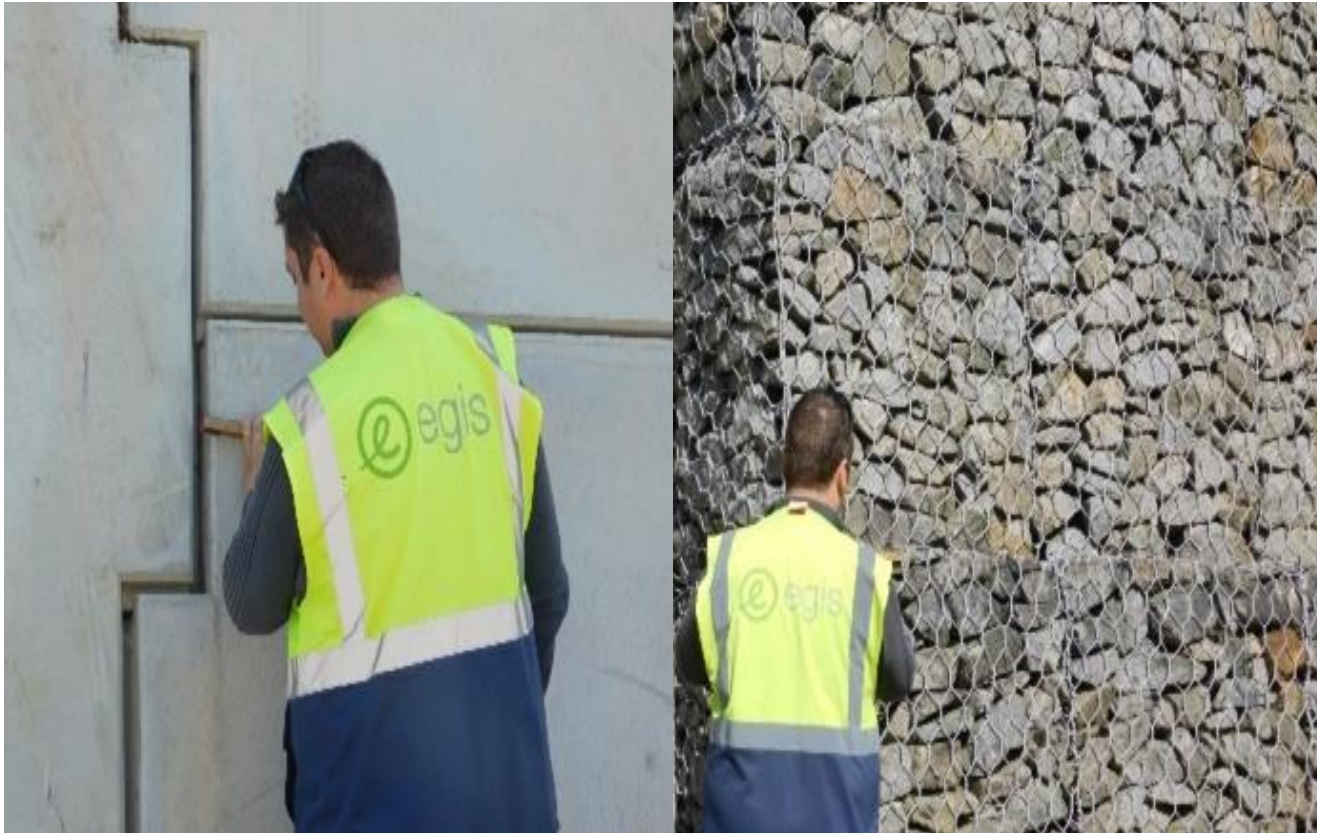
Inspections

- Periodic visual inspections
- Output
 - Conservation state
 - Defects
 - Works required

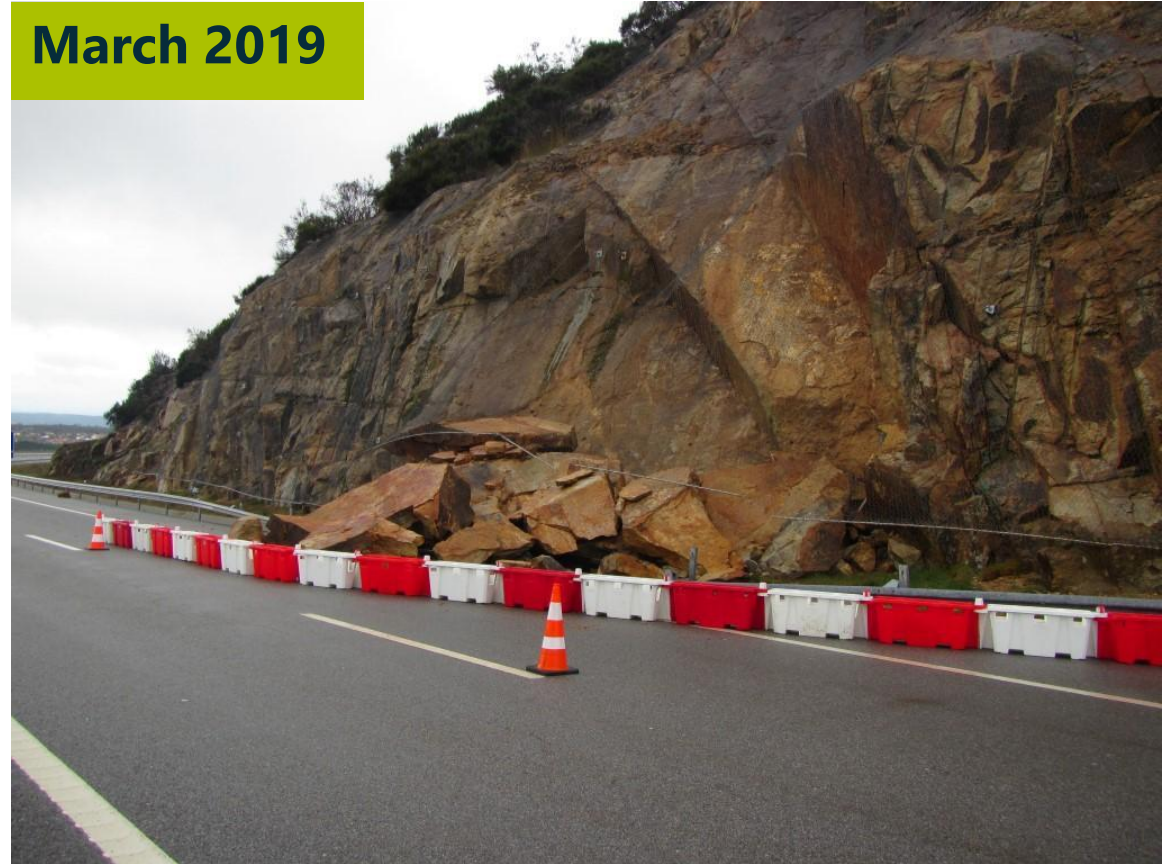
However...it may not be enough!

March 2019

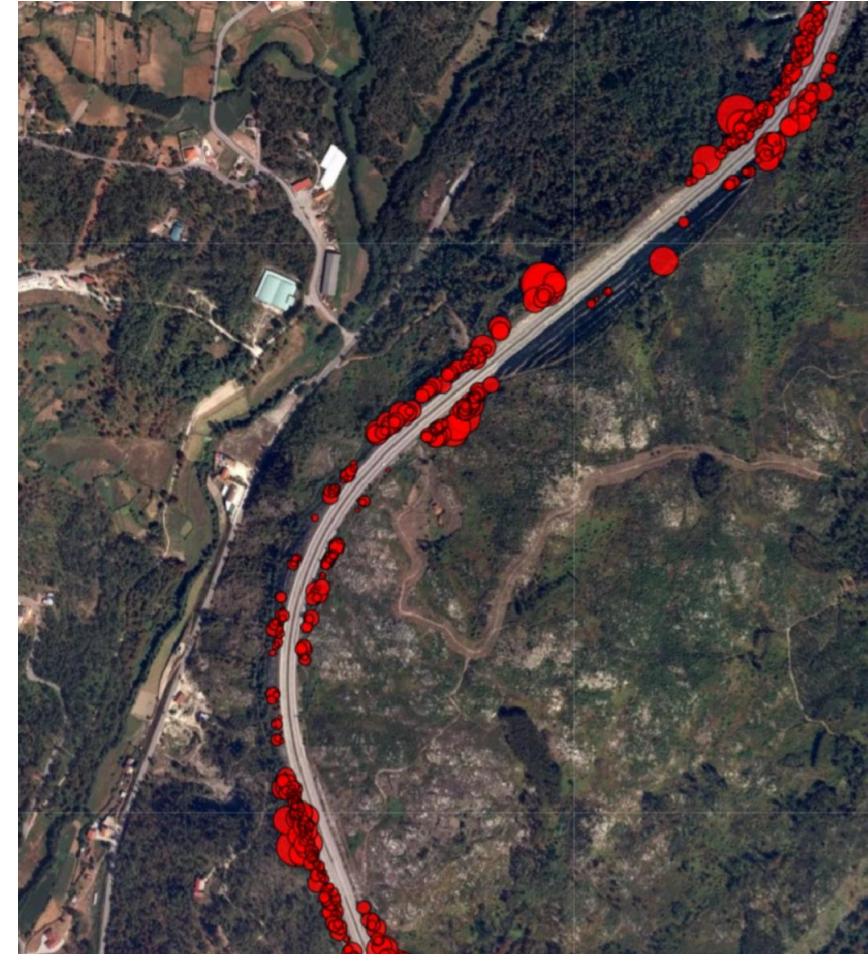
— VEGETATION MANAGEMENT

- **Normalized Difference Vegetation Index-NDVI**

Quantify the **amount of chlorophyll**, which is the element responsible for the green of the vegetation

- **Tree detection with AI**

High accuracy definition of polygons encircling the trees

- **Dead Tree detection**

The **correlation** between **NDVI** and **tree detection** makes it possible to detect dead trees

- **Tree Height & Fall Radius + Vitality**

Detecting tree height from shadow using AI and trigonometry formulas

- **Vegetation intensity per KP**

Identify the primary vegetation type adjacent to the road at each kilometer
